Information Bulletin #2022-2

Problem: Water infiltration into the wind generator.

Equipment: All wind generators.

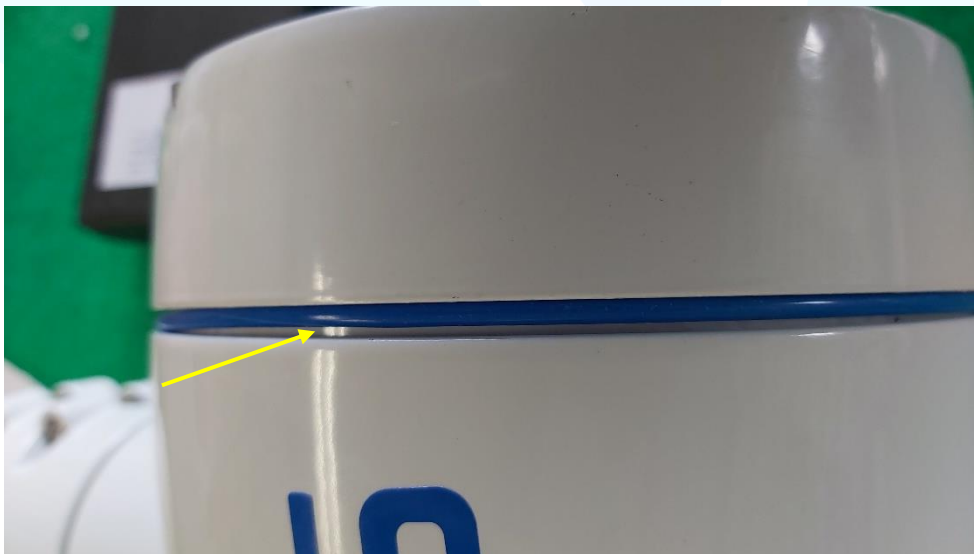
Photo 1 – Front face not completely closed - example

- The screws from the Front Face not completely screwed.
- O-Ring is not in place.
- No O-ring.
- Stator is not correctly inserted.

- Is there any visible damages on the O-Ring?
- Is the O-Ring fitted correctly?
- Observed any gaps between the front face and the body of the wind generator?
- Are the 3 Front Face screws firmly screwed?

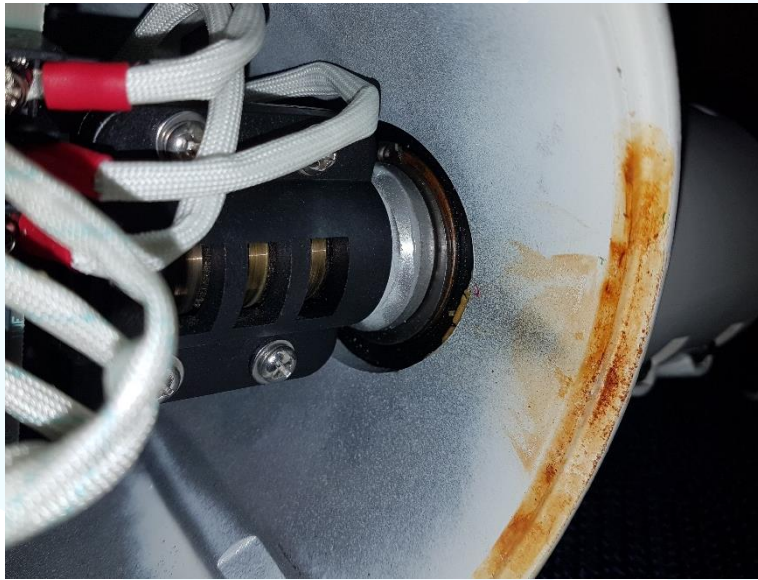
- Corroded yaw bearings - The wind generator will not rotate according to the wind direction.
- Corroded rotor and stator.
- Energy production is affected.

Photo 2 – Water infiltration – Customer photo

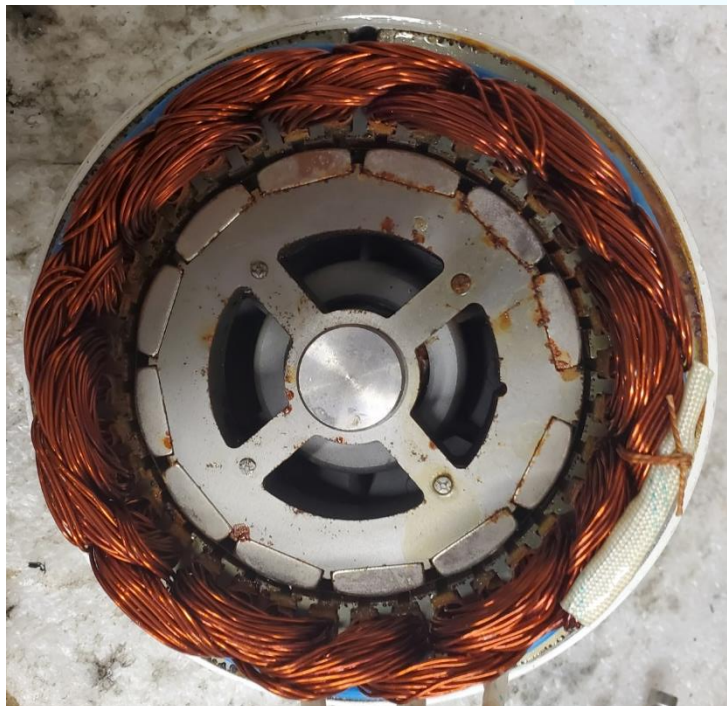
Photo 3 – Water infiltration – Customer photo

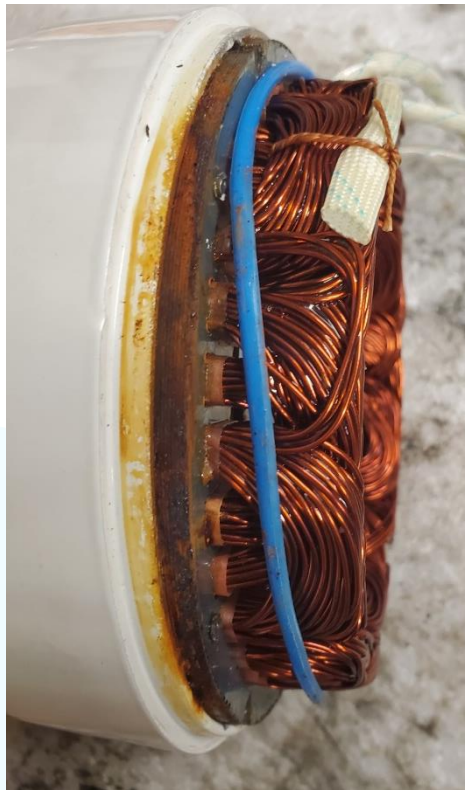
Photo 4 – Water infiltration – Customer photo
